## For Banksmeadow Transfer Terminal

Document Code: PLA-NSW-XXX-XXX-1

Soil, Water and Leachate Management

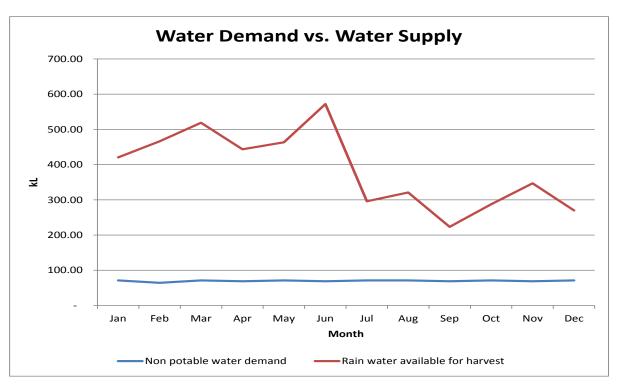
#### Figure 3.1 Water supply vs. water demand

Figure 3.1, from the BTT EIS (Hyder 2014) provides the difference between the potential for water harvesting and water demand for the BTT over the course of a year.

The water balance assessment concluded that the equivalent of 40 kL of rainwater storage would accommodate the non-potable water demand for the BTT operations.

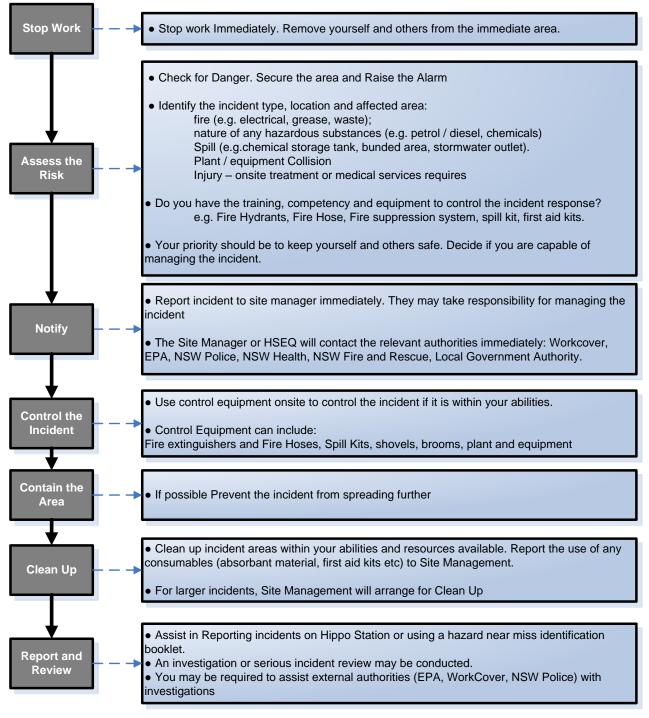
#### **Emergency and Environmental Incident Response Flow-Chart**

This flowchart provides a basic guideline to emergency response. As such it cannot predict every emergency situation that could occur. Never place yourself or others at risk when following these procedures. Refer to your site Emergency Response Plan for further information.

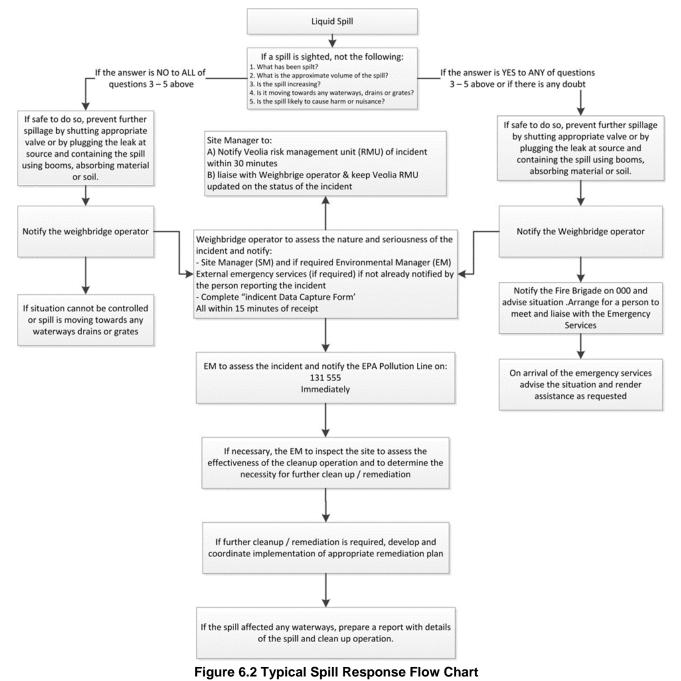
Any fuel, lubricant, or hydraulic fluid spillages is contained through the design of site bunding, and any excess material is collected using absorbent material, with contaminated material disposed of to a licensed waste facility.

A typical spill response procedure to be followed by Veolia is summarised in Figure 6.2 below.

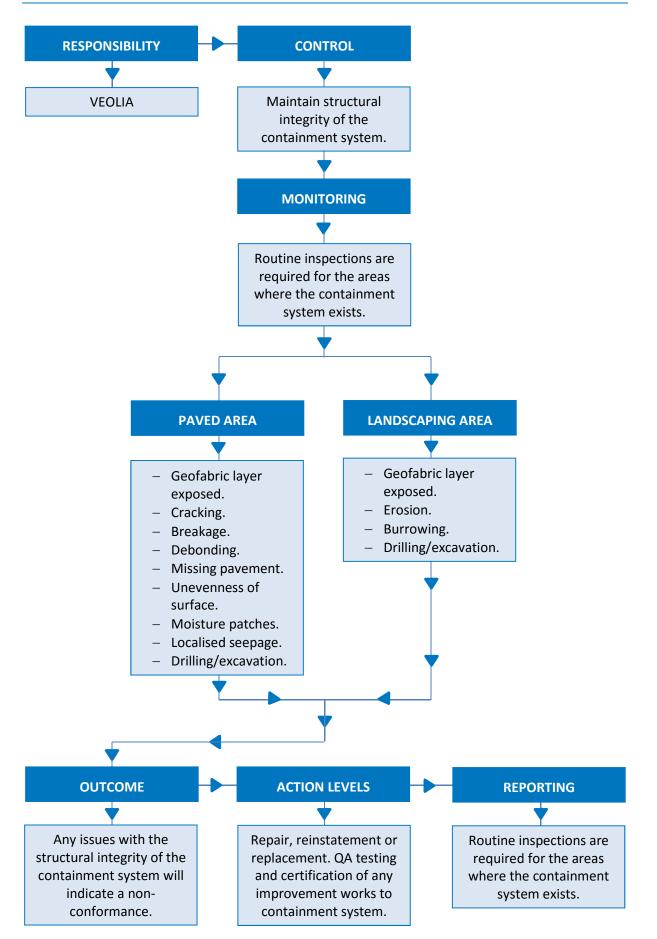
- Action Levels: Any non-conformance in the physical qualities of the containment system will be appropriately addressed through repair, reinstatement or replacement. Any repairs to the containment system should be tested for Quality Assurance (QA) and certified to comply with the original design specifications.

A schematic of this process is provided below.

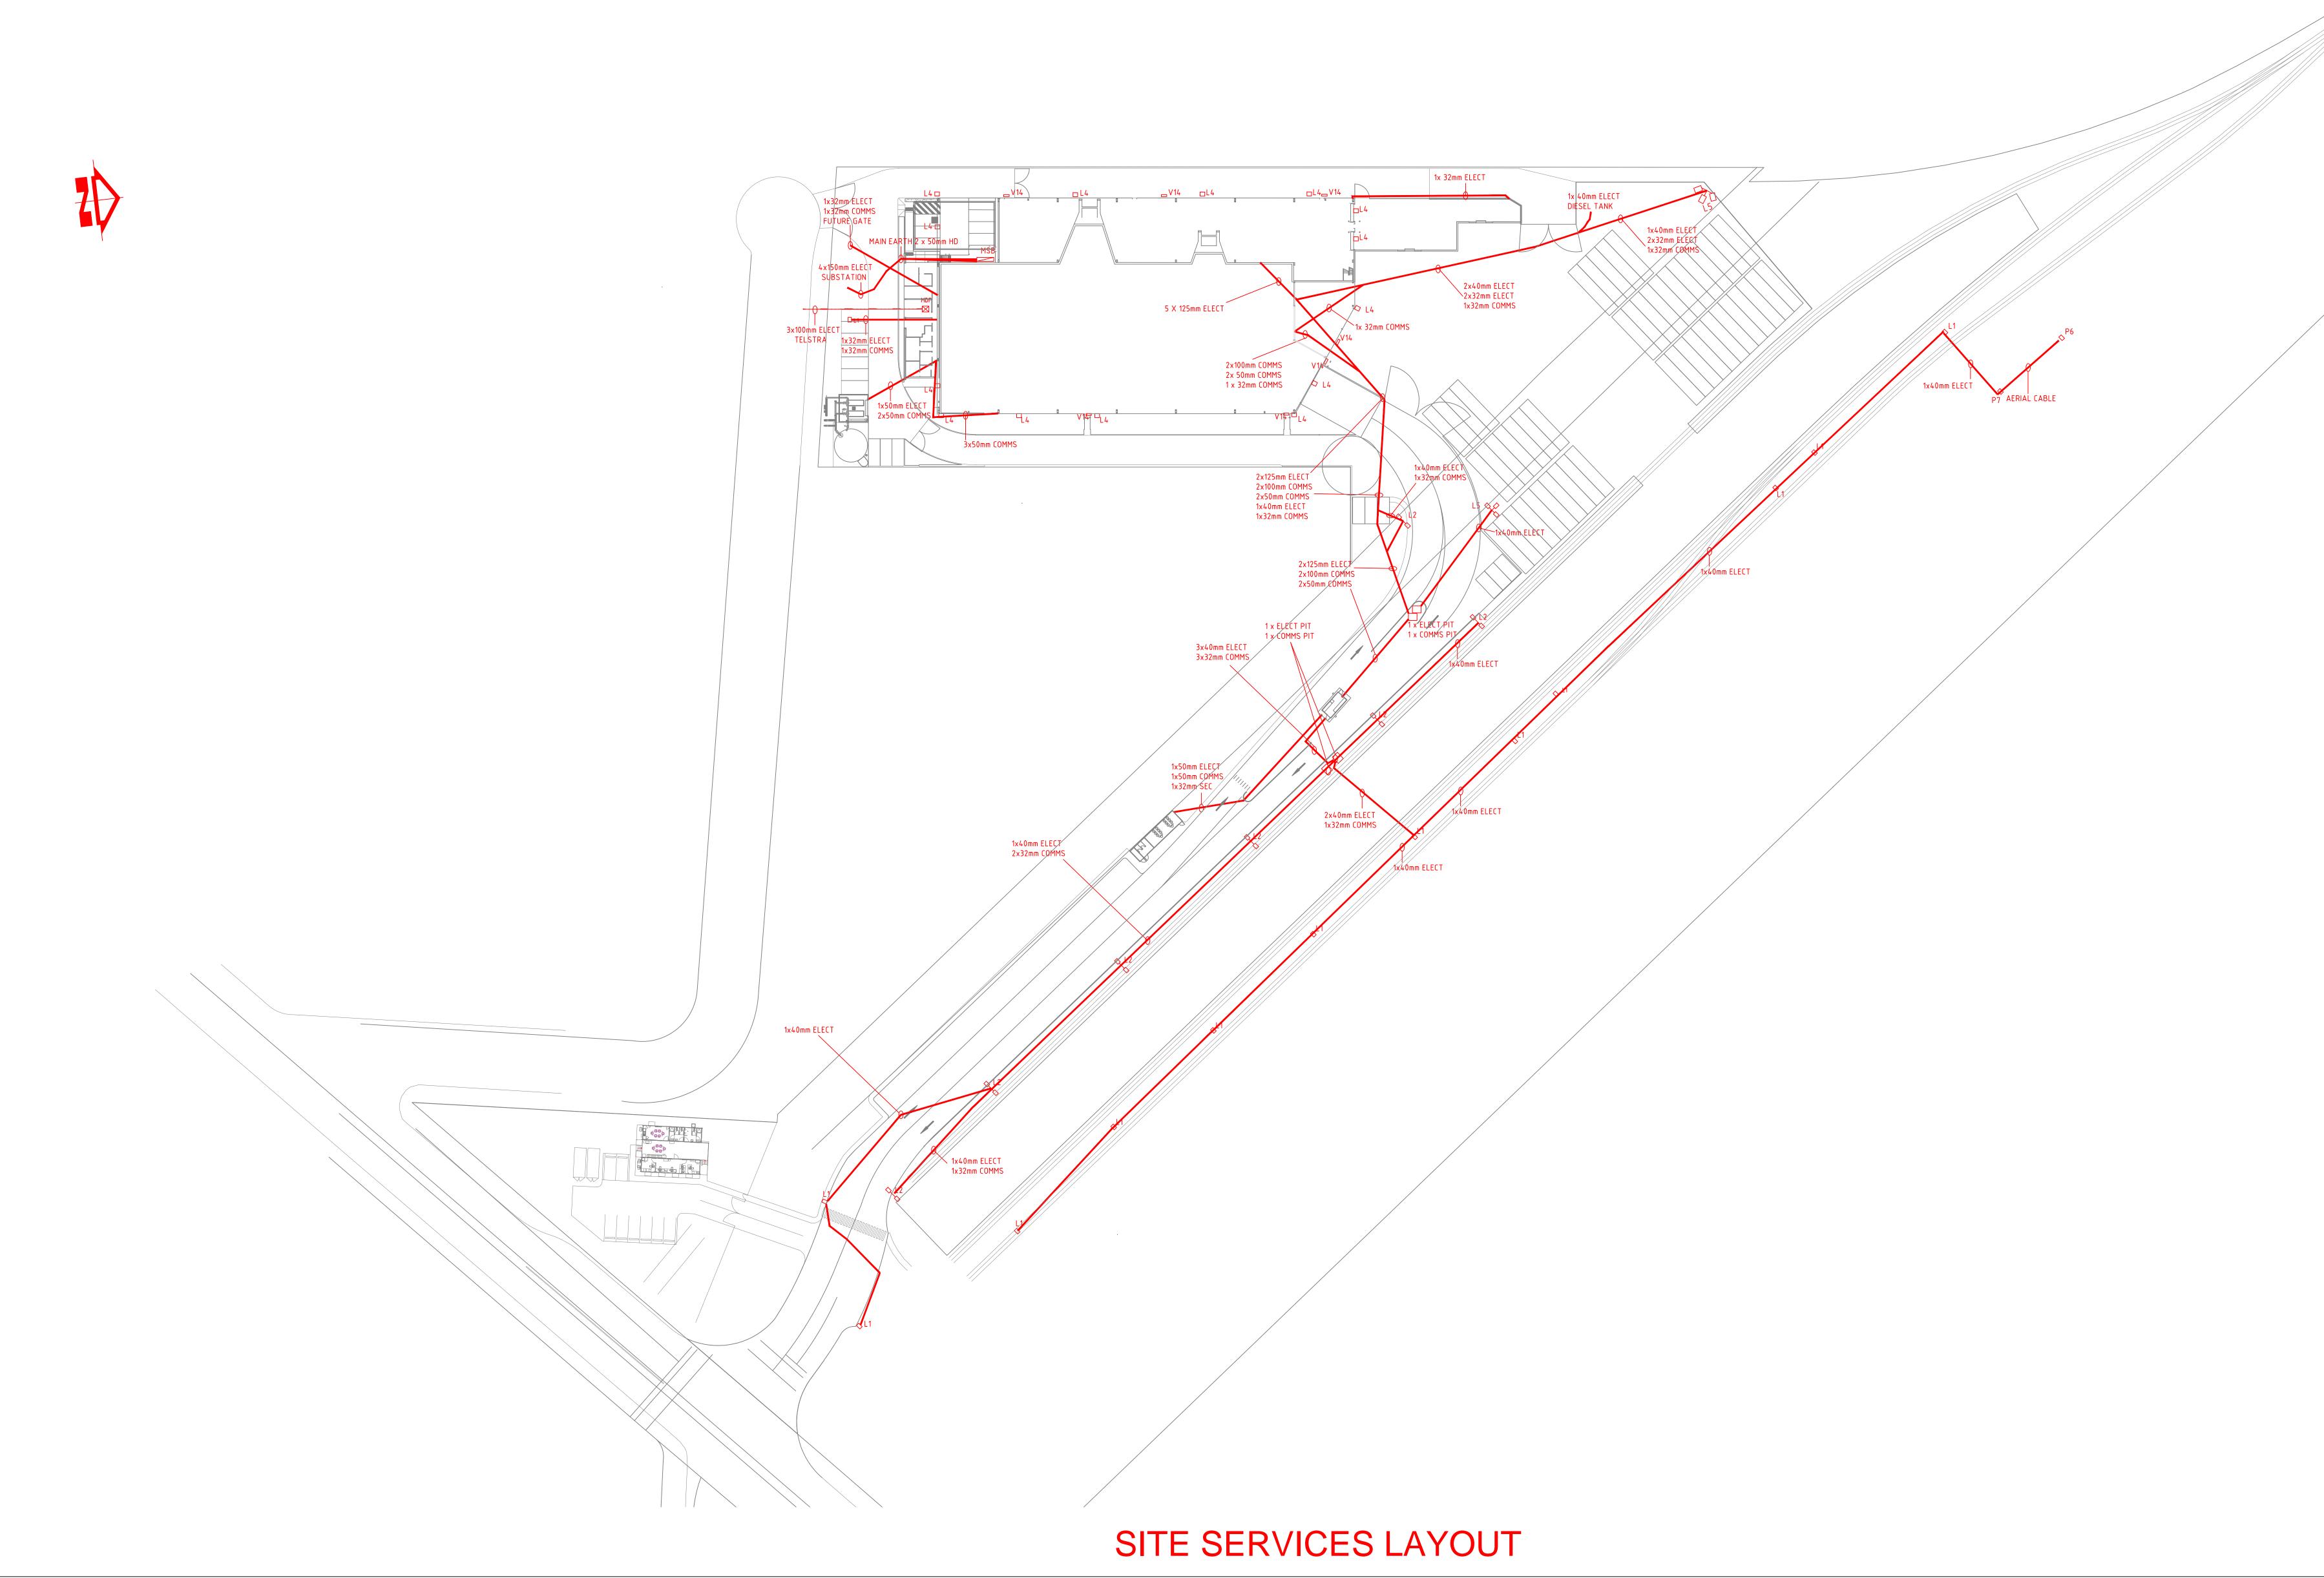
FIGURE 5 – SERVICES PLAN

PROJECT:		PROJECT NUMBER:	DRAWING NUMBER:	
BANKSMEADOW T	ERMINAL	LV	E-001	
CLIENT:		DRAWING NAME:		
LIPMAN PTY LTD		SITE SERV	ICES LAYOUT	
DRAWING STATUS:		SCALE:	DATE:	
CONSTRUCT	ION	1:500@E	31 23/06/16	
ALL WORKS TO FOLLOW WRITTEN DIMENSIONS, DO NOT SCALE DIMENSIONS

Figure 1	Site Location
Figure 2	Site Development Plan
Figure 3	Fill Depths and Marker Layer
Figure 4	Site Surface Finishes and layout
Figure 5	Services Plan
Figure 6	Landscaping Areas

A plan showing the location of services installed at the Site has been included as **Figure 5** of this document.

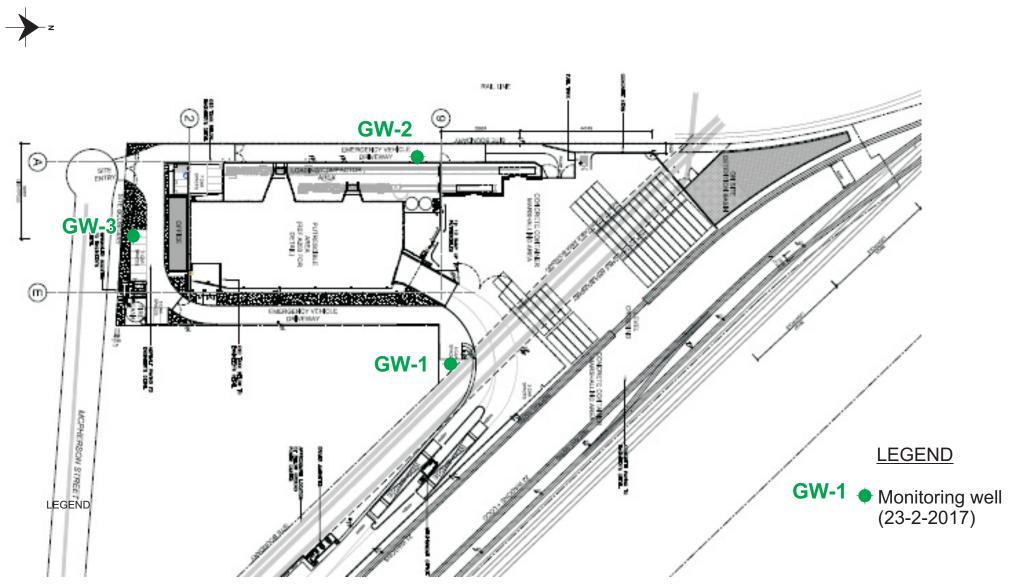
Appendix F Groundwater wells locations

Site Layout & Well Network (Feb 2017)
